REPORT OF FLOOD
14-16 MARCH 1978
CHAGRIN AND GRAND RIVERS
OHIO

U.S. ARMY ENGINEER DISTRICT, BUFFALO
JUNE 1978

REPORT OF FLOOD 14-16 MARCH 1978
CHAGRIN RIVER BASIN
STAGE HYDROGRAPHS

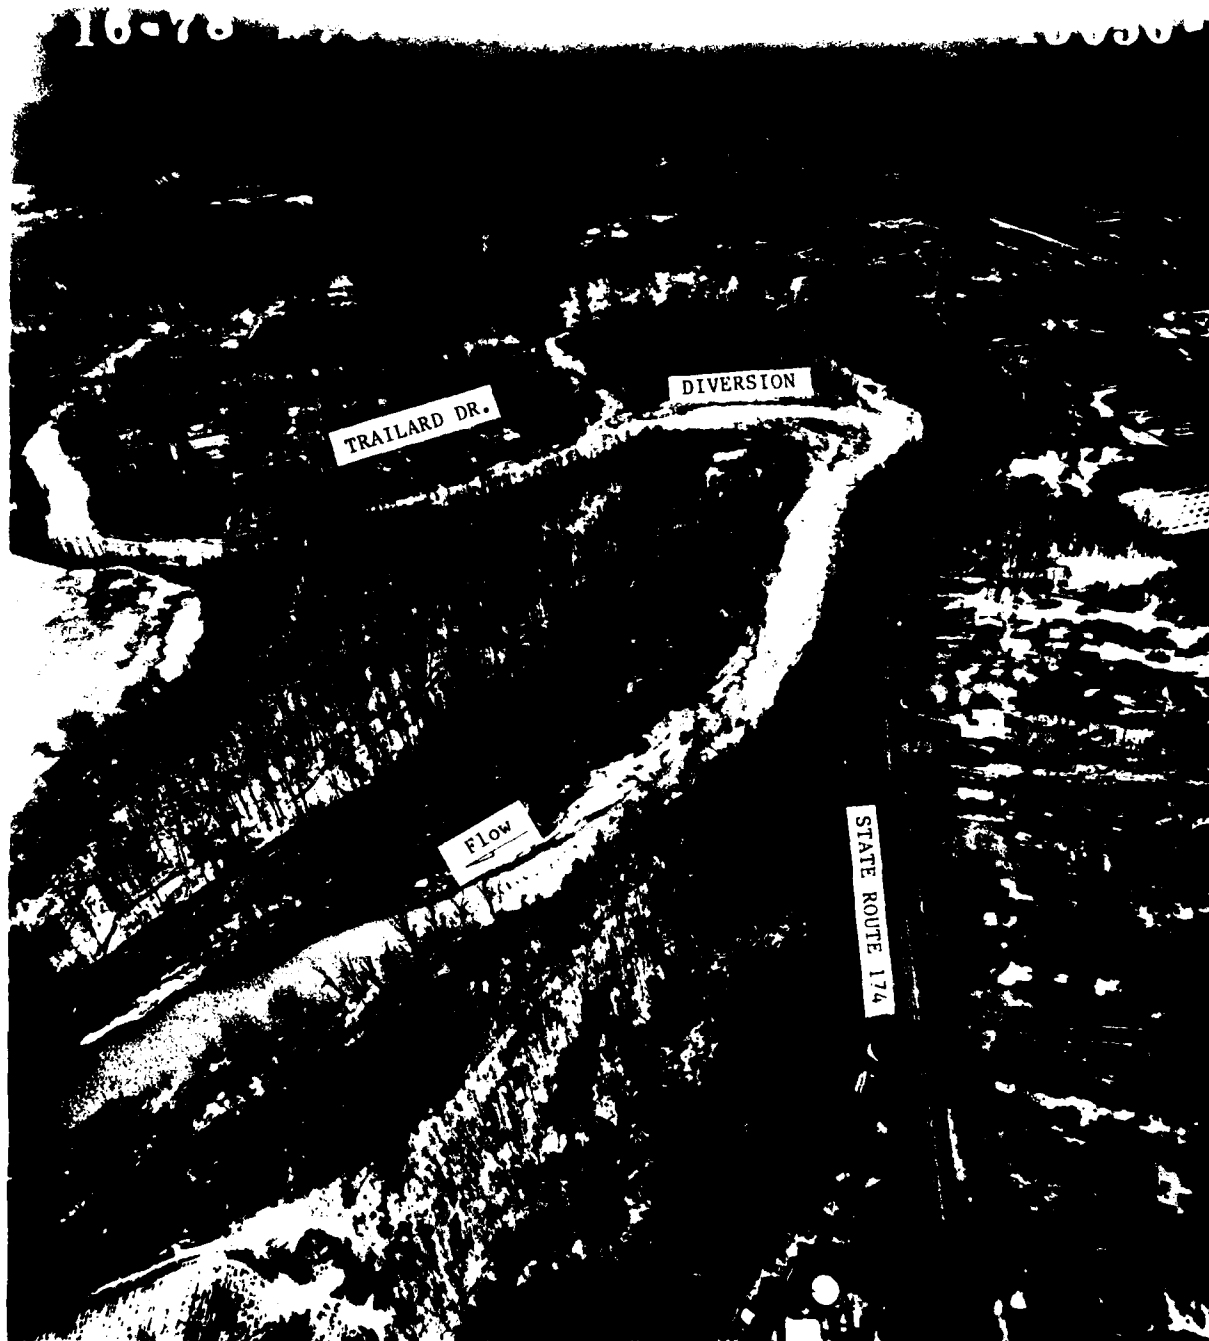
Photo 1 - Aerial view of the Chagrin River, Trailard Drive area showing local channel diversion project. Photo taken by Kucera & Associates, Mentor, Ohio, 16 March 1978

Residents of the Trailard Drive area (Horseshoe Glen) were not as severely affected as the other Willoughby Hills developments located upstream. The local river diversion project in the Horseshoe Glen area was probably instrumental in reducing damage there.

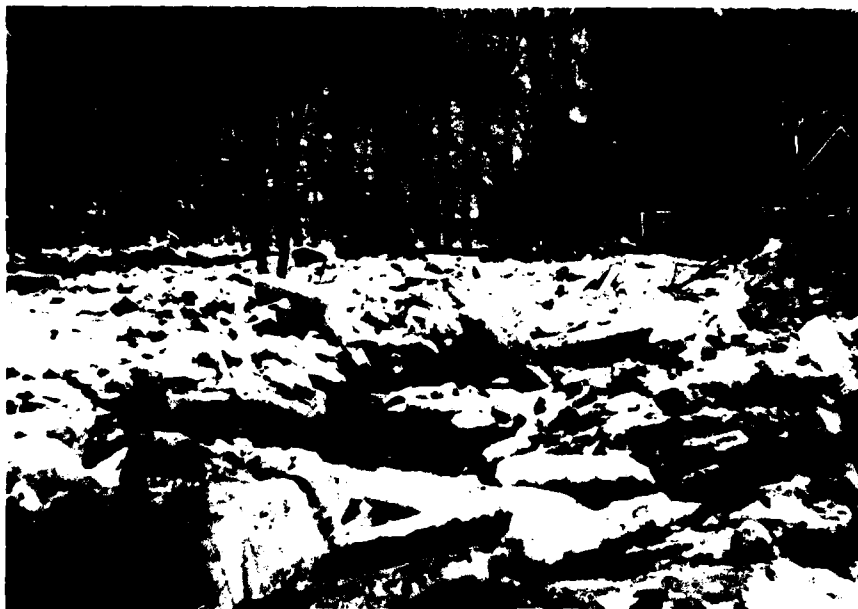
Photo 2 - Ice forced from river onto lawns and yards of Milann Drive residents at mile 10.3.

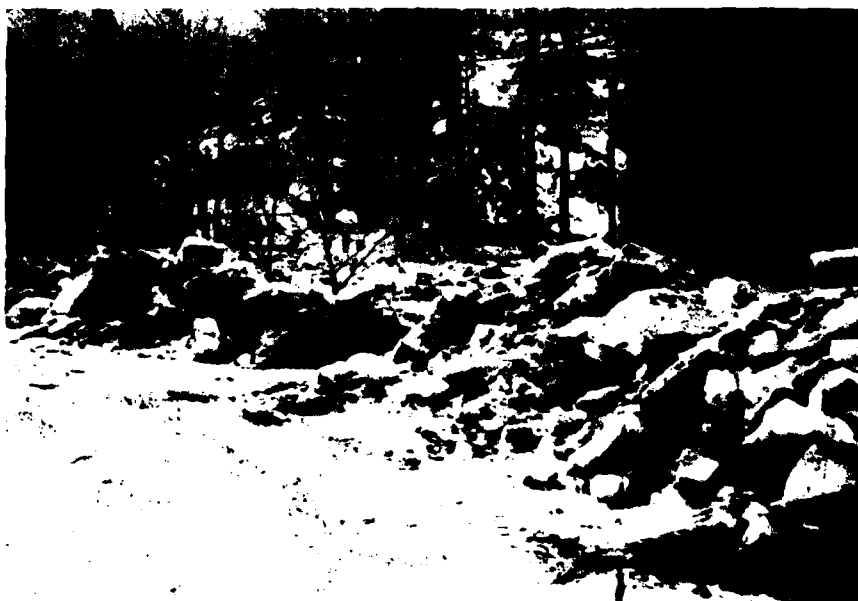
Photo 3 - Ice had to be plowed from Milann Drive to permit access for emergency vehicles.

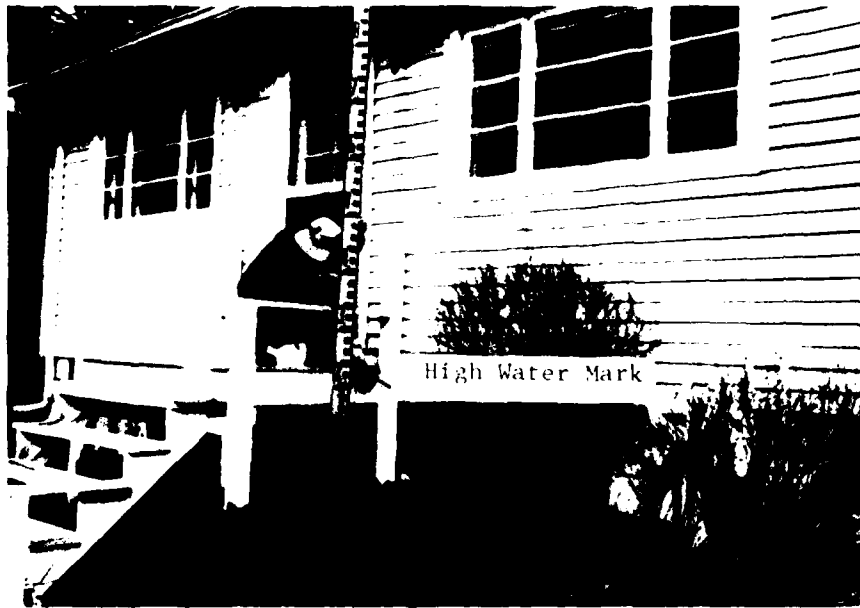
Photo 4 - Residence on Milann Drive mile 10.2 barely escaped first floor inundation.

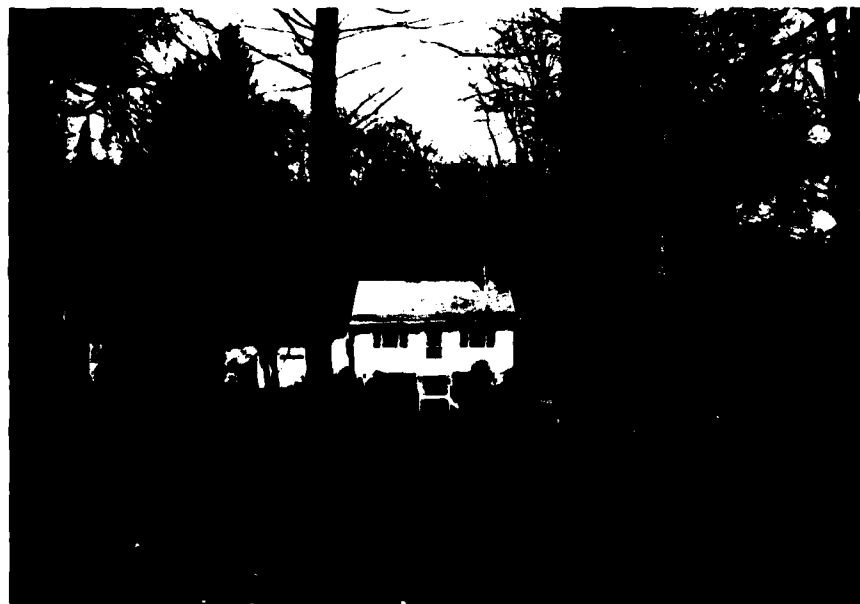
Photo 5 - Same residence as above. Pressure of water and ice caused the collapse of the basement wall.

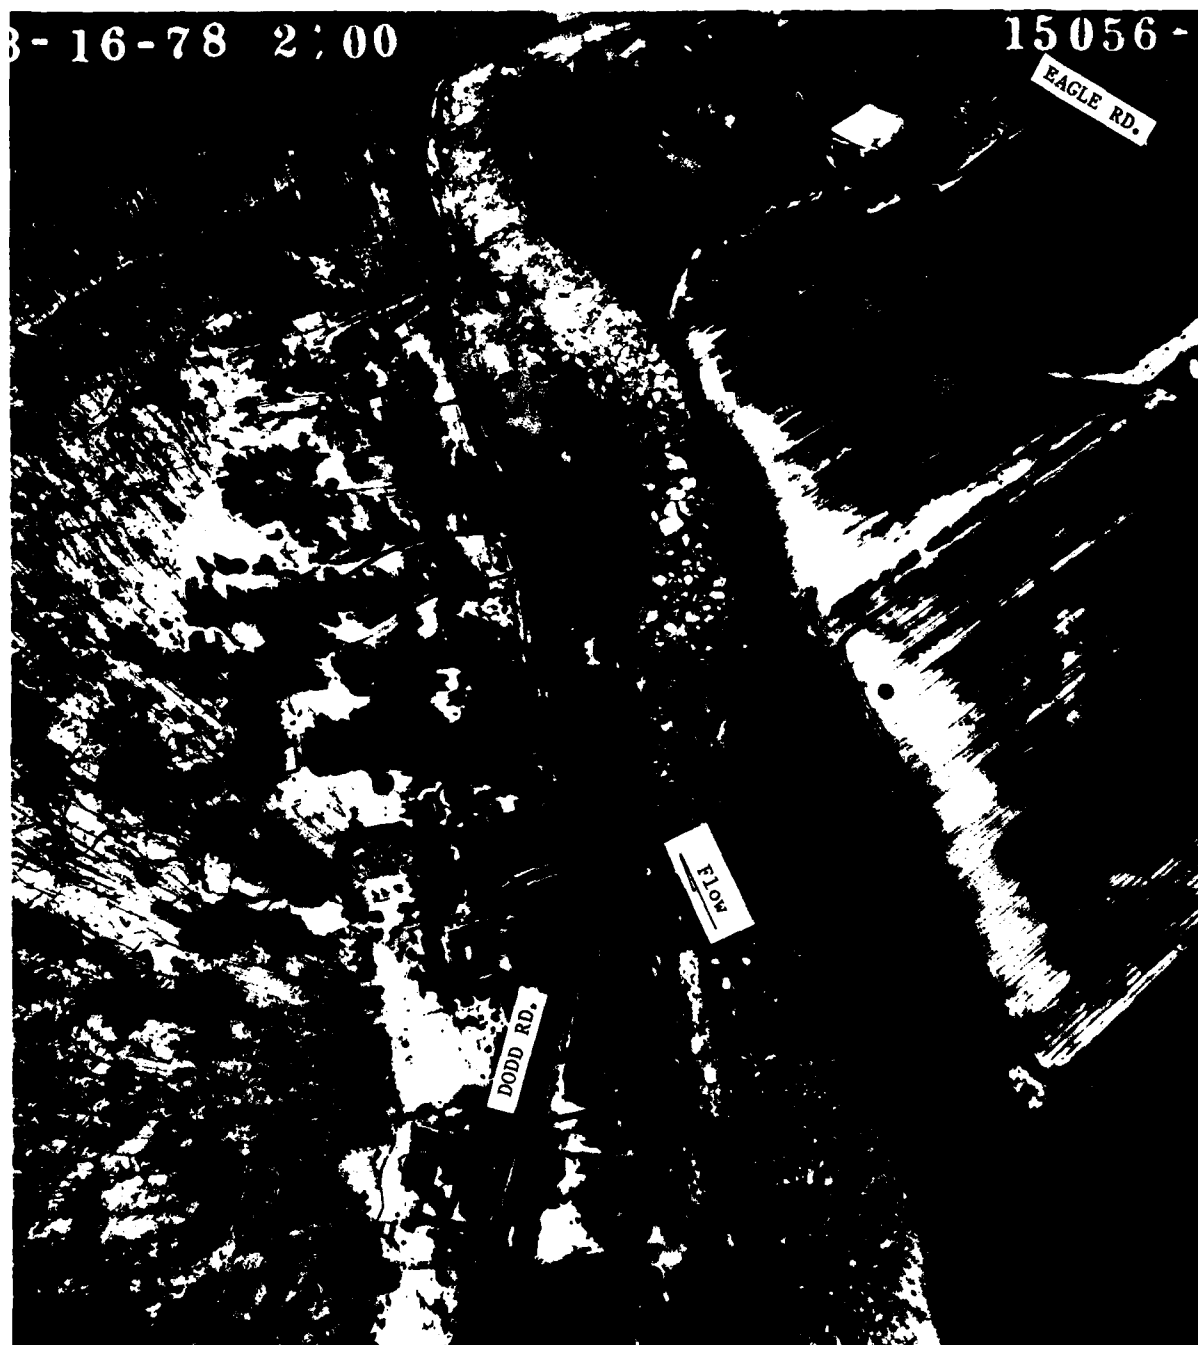
The ice began to jam again just upstream from the bridge at Eagle Road. The rising water diverted around the jam through the Chagrin Drive area overtopping Eagle Road on the right bank (Mile 8). Heavy damage occurred here to 20 homes, some of which had several feet of water on the first floor. At approximately 12 noon, the water level at the Eagle Road staff gage rose to 16 feet, 3 feet above flood stage. At 8:00 p.m., fire department officials reported the river peaked at 18 feet, covering Dodd Road. Normal water level for the Eagle Road gage is 4 to 6 feet.

Photo 6 - Aerial view of the ice jam just upstream of Eagle Road and subsequent inundation along Dodd Road. Photo taken by Kucera & Associates, Mentor, Ohio, 16 March 1978.

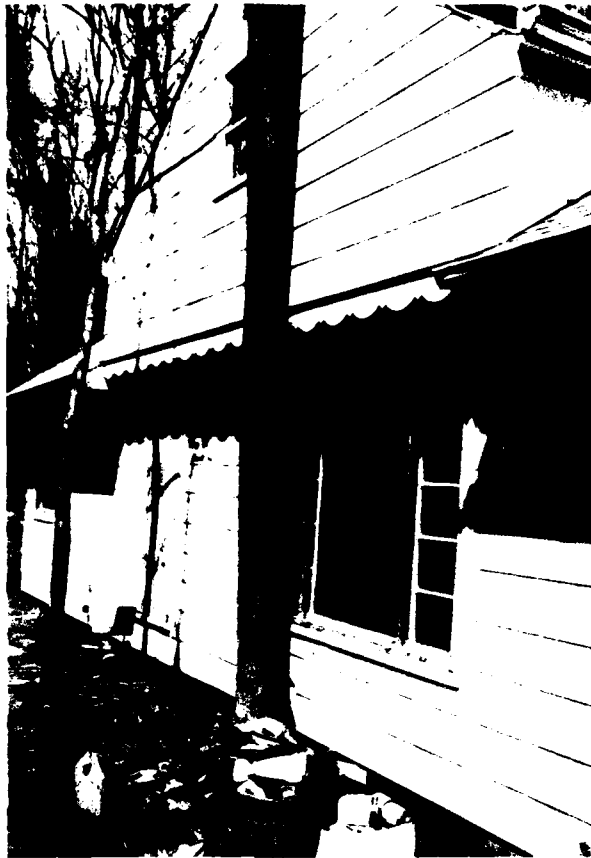
About 11:30 a.m., the jam broke sending a wall of water and tons of ice downstream toward the Dodd Road and Trailard Drive communities. The first house in the path of the wave on Dodd Road was lifted from its foundation and displaced several feet (Photo 7). A few hundred feet down Dodd Road other houses were flooded nearly to the first floor ceilings. The water rose so fast that automobiles were floated away and deposited elsewhere downriver.

Photo 7 - Home on Dodd Road river mile 3.4 floated from foundation and lodged against tree.

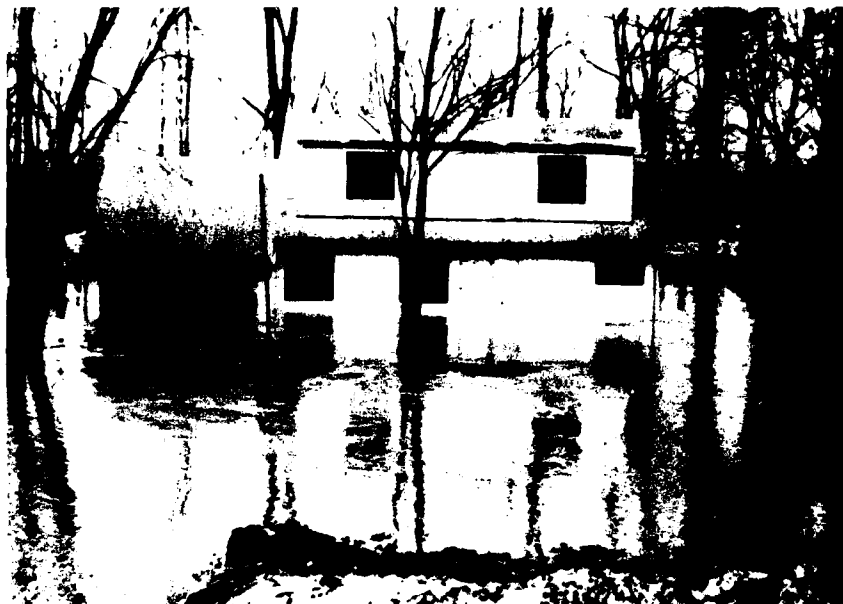
Photo 9 - Dodd Road residence, mile 8.3, taken shortly after peak flow, 15 March 1978

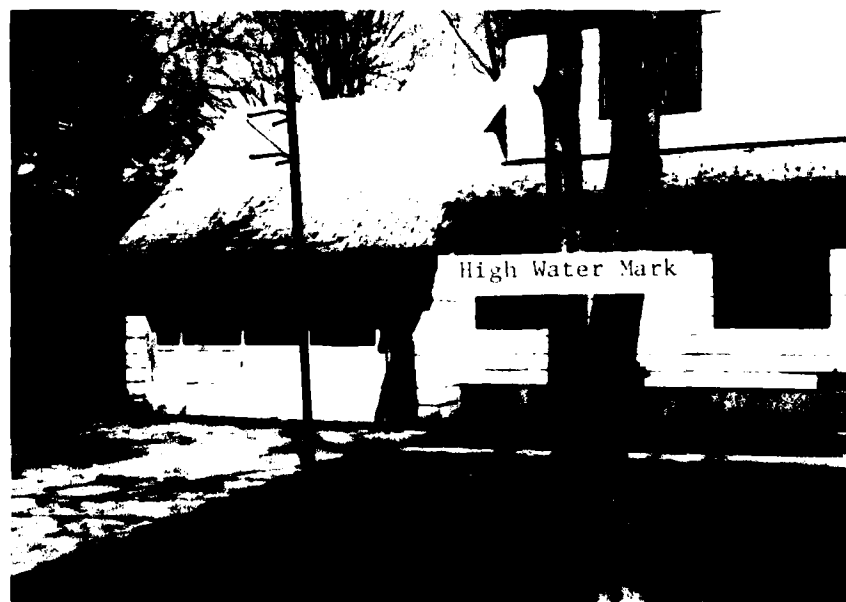
Photo 10 - Same residence as above showing high water mark.
Photo taken 6 April 1978

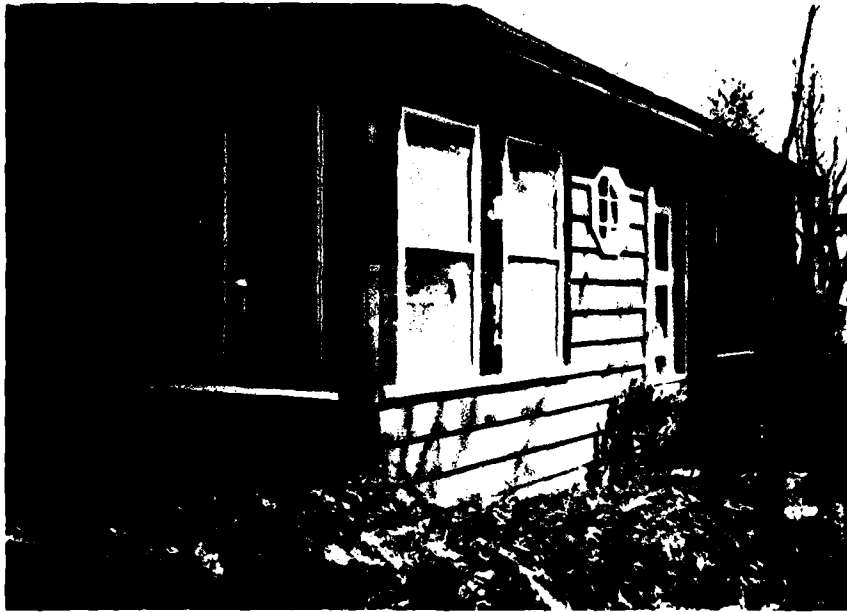
Photo 11 - River front residence on Dodd Road, mile 8.3.
Note high water mark visible on front windows.
Photo taken 6 April 1978

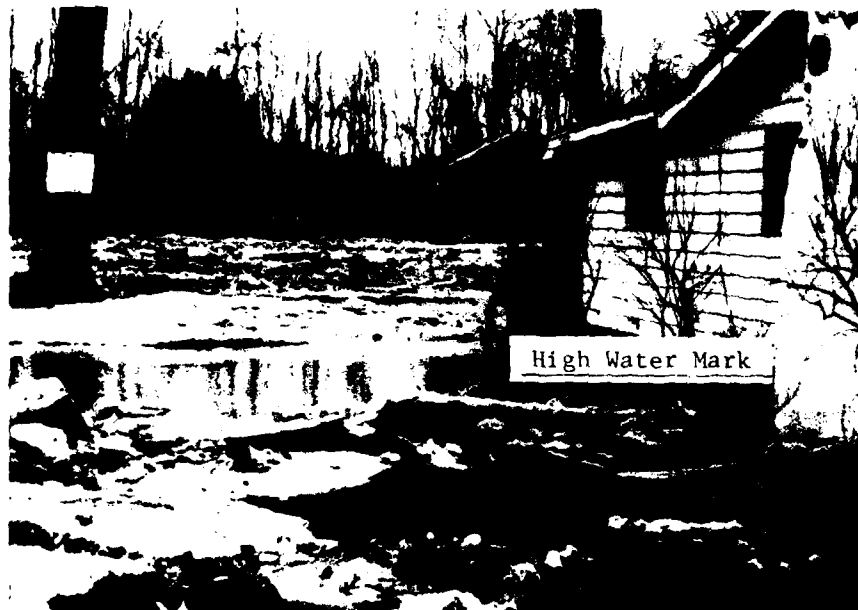
Photo 15 - Residence on Trailard Drive, mile 7.9. Photo taken after peak flow had passed 16 March 1978.

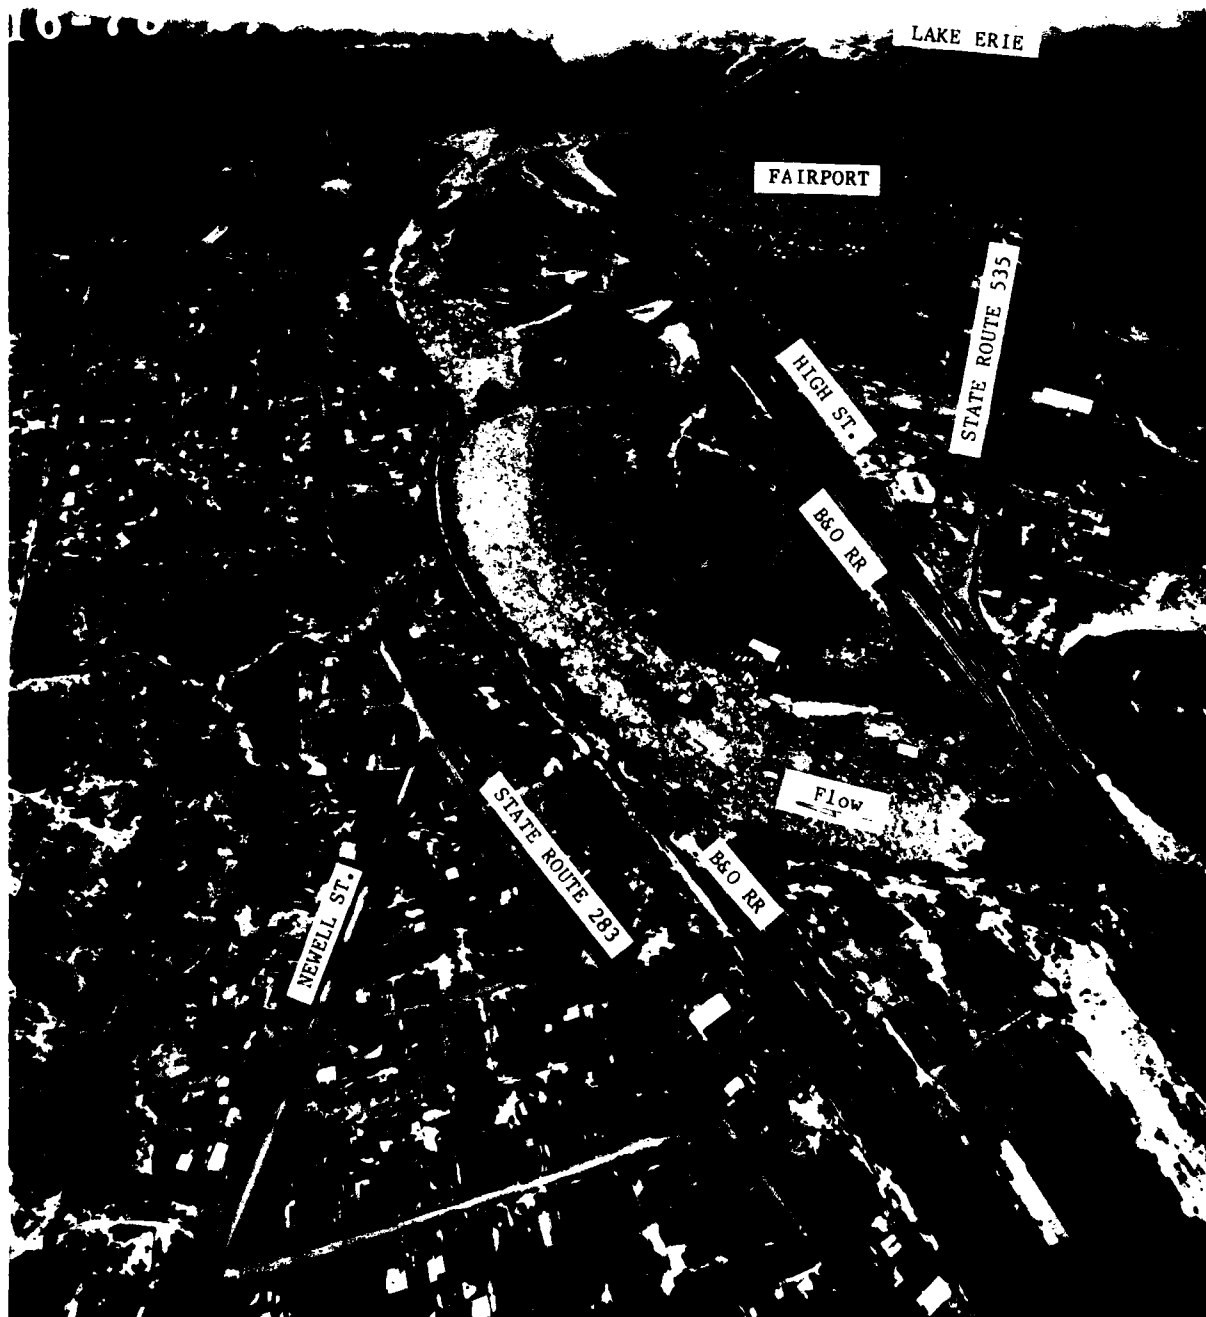
Photo 17 - The Grand River looking north from Painesville toward Fairport and Lake Erie. Photo taken by Kucera & Associates, Mentor, Ohio, 16 March 1978.

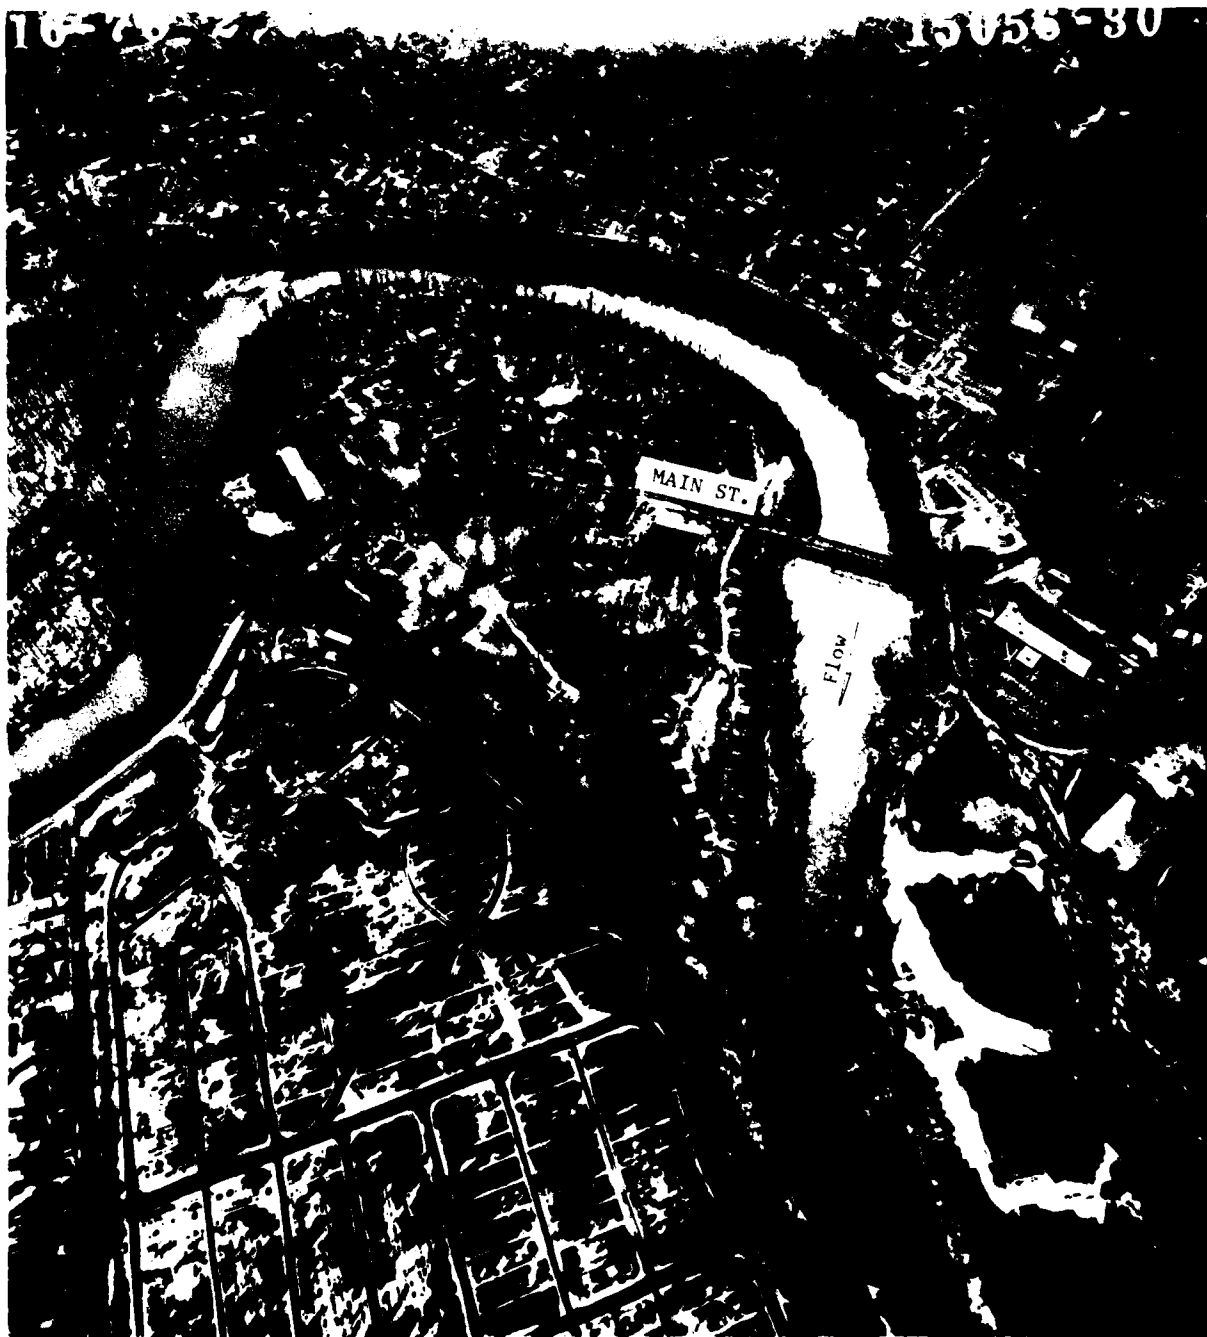
Photo 18 - The Grand River at Painesville showing low-lying apartments (center of photo). Taken by Kucera & Associates Inc., Mentor, Ohio, 16 March 1978.
